RE: 2023 BRIDGE INSPECTION REPORT

BIN	MILEPOST	DESCRIPTION
5513180	108.62	Brick School House Road Over the Thruway

New York State Department of Transportation General Bridge Inspection Report

Inspection Date: October 05, 2023

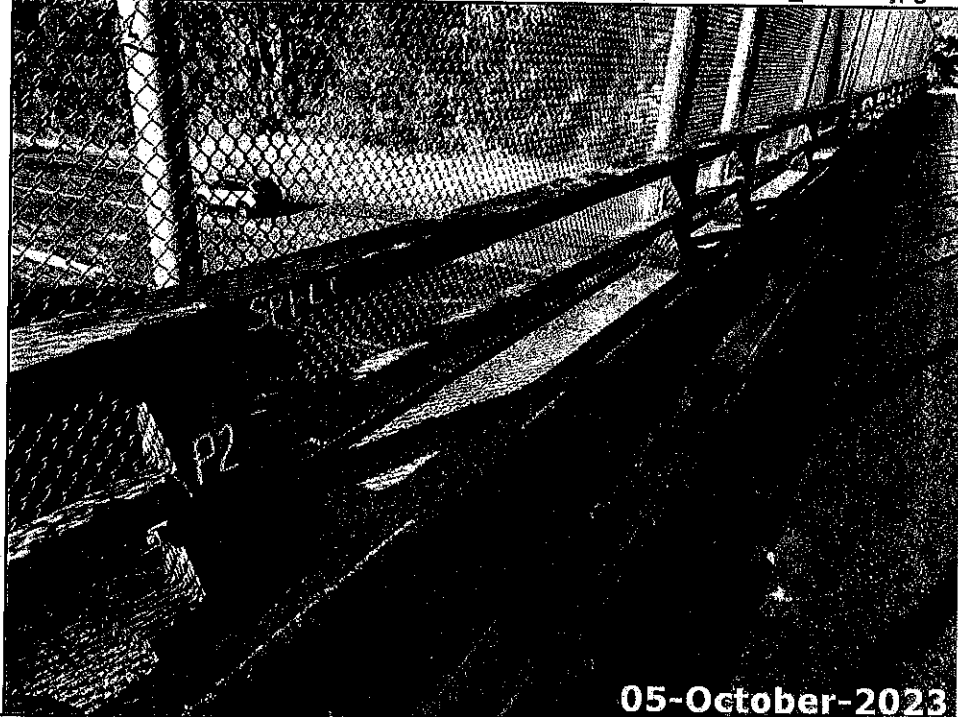
Photo Number: 3

-The railing is generally rusty with paint failure and minor pitting throughout (photos 01, 02, 03).

Attachment Description:
Span 1 left side rail at post
#2 looking end; showing
rusting of rail and failure of
paint.

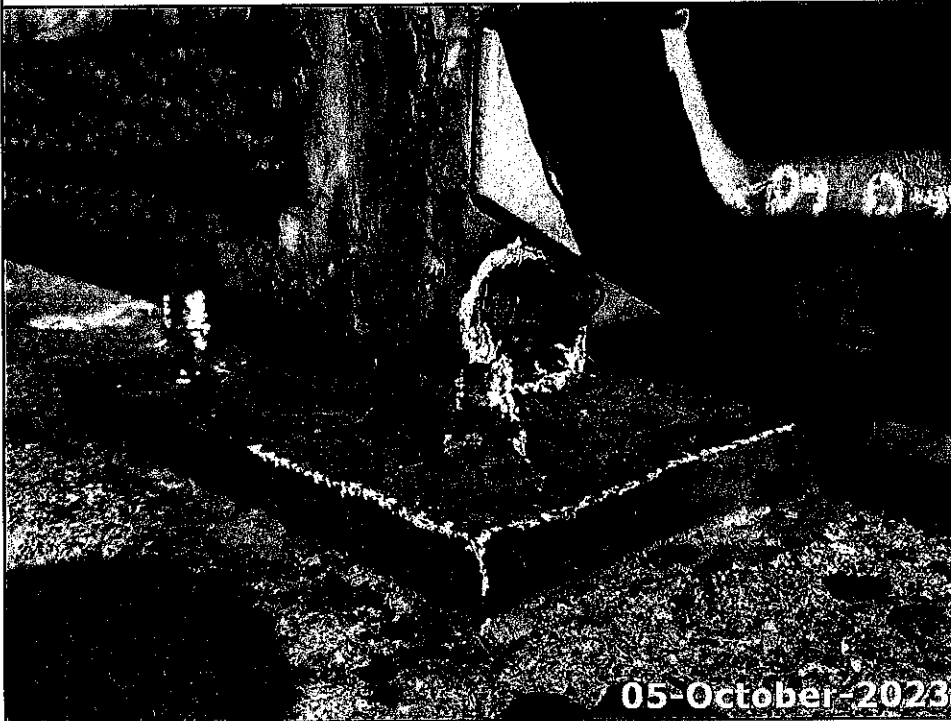
Photo Number: 5 Photo Filename: MP108.62_05-20231005_101252.jpg

-Span 2, right side, post #2; 2.5" diameter perf at begin-side base (photo 05)

Attachment Description:
Span 2 right side rail at post
#2 looking right/end;
showing perforation at base
of post on begin side.

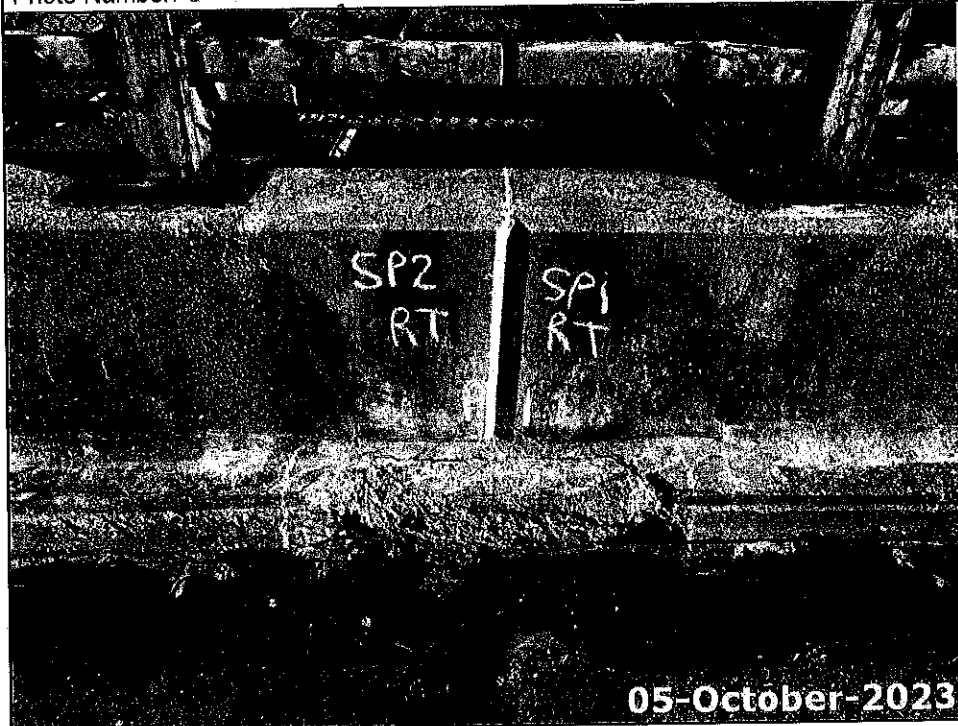
Photo Number: 8

A localized section of spalled concrete curbing is located directly above the pier, on the right side, affecting equal lengths of spans 1 and 2 curbing.

The affected length is spalled 2'L x 6"H x 2"D, affecting 1LF within each span.

Attachment Description:
Spans 1 & 2 right side curb at pier 1, looking right; spalling concrete curb.

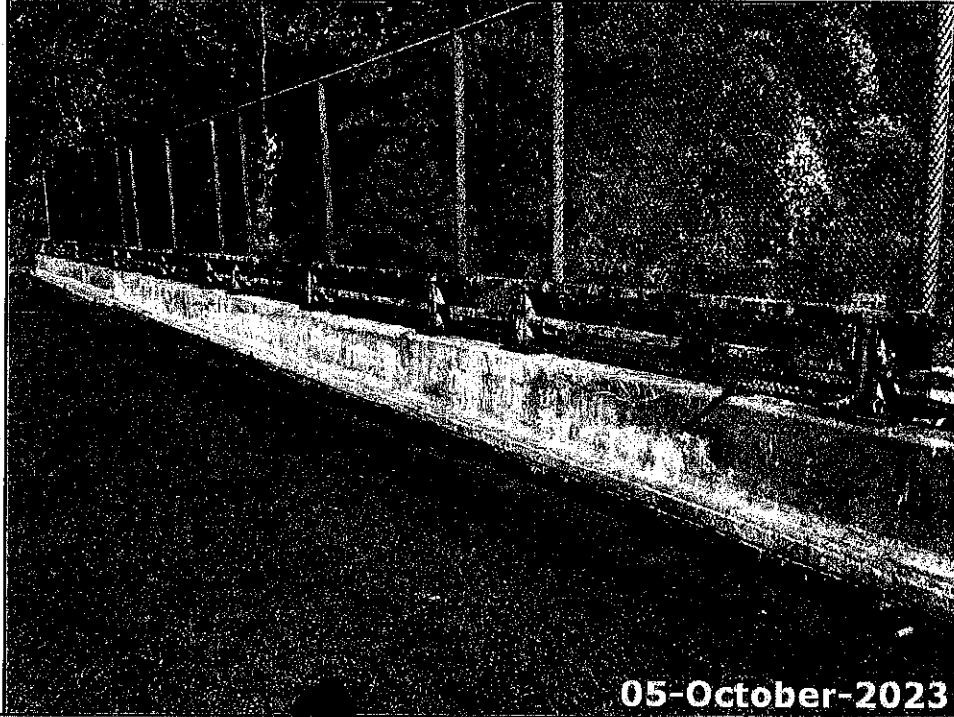
Photo Number: 9

The right side concrete rail within span 2 shows notable CS-3 deterioration from approximately 1/4-span to the end of the span (see photos 09 and 10). The top face/edge of the barrier within the area is spalled up to 24'L x 16"W x 4" deep, with crumbly exposed concrete. The inboard face and remaining top edge is cracked and delaminated with moderate-to-heavy efflorescence staining.

Attachment Description:
Span 2 right side concrete parapet wall, looking end; showing deteriorating concrete from 1/4 span to end including spalling, delamination, cracking and efflorescence.

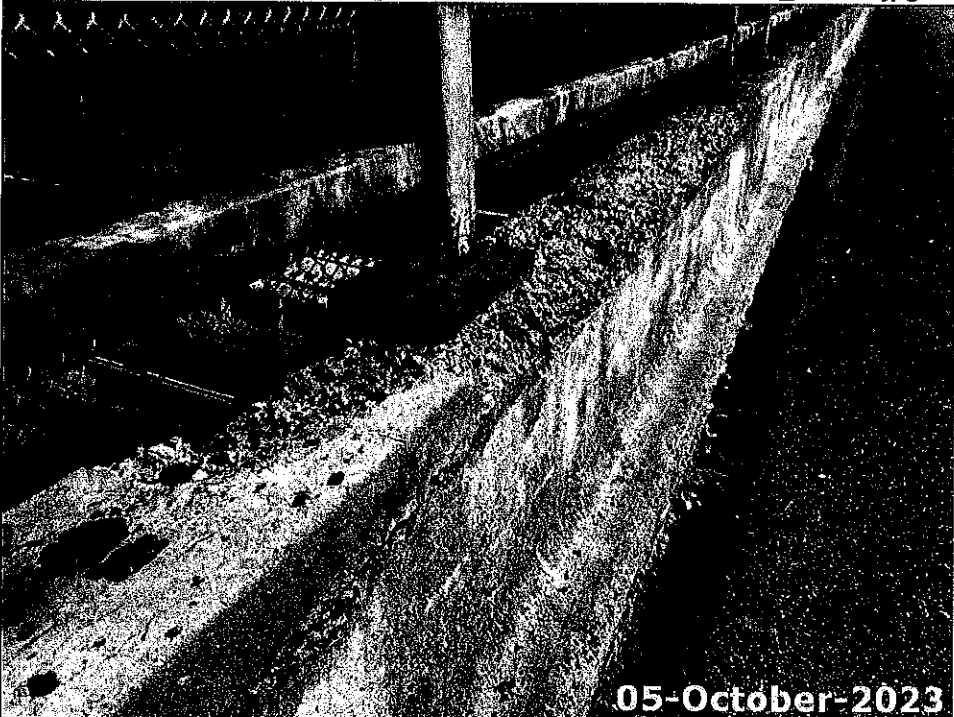
Photo Number: 10

Attachment Description:
Span 2 right side concrete parapet wall, looking begin; showing heavily spalling section of parapet wall.

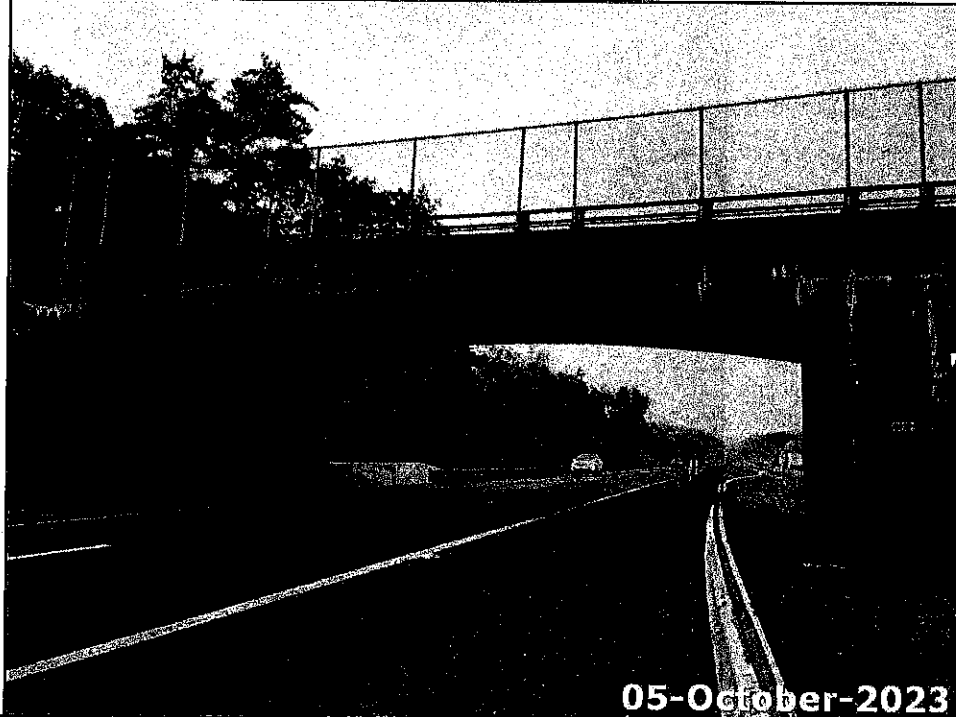
Photo Number: 12

- Cracking with efflorescence staining is seen on the left face at the end of the span directly above pier 1.
- Four shallow pop-outs ~4"W x 12"H each, are seen on the right-fascia headwall near mid-span, due to shallow cover of underlying reinforcing steel.

Attachment Description:
Span 1 right fascia (NB)
looking left; showing
general condition and
configuration of elements,
including 4 small pop outs
and efflorescence.

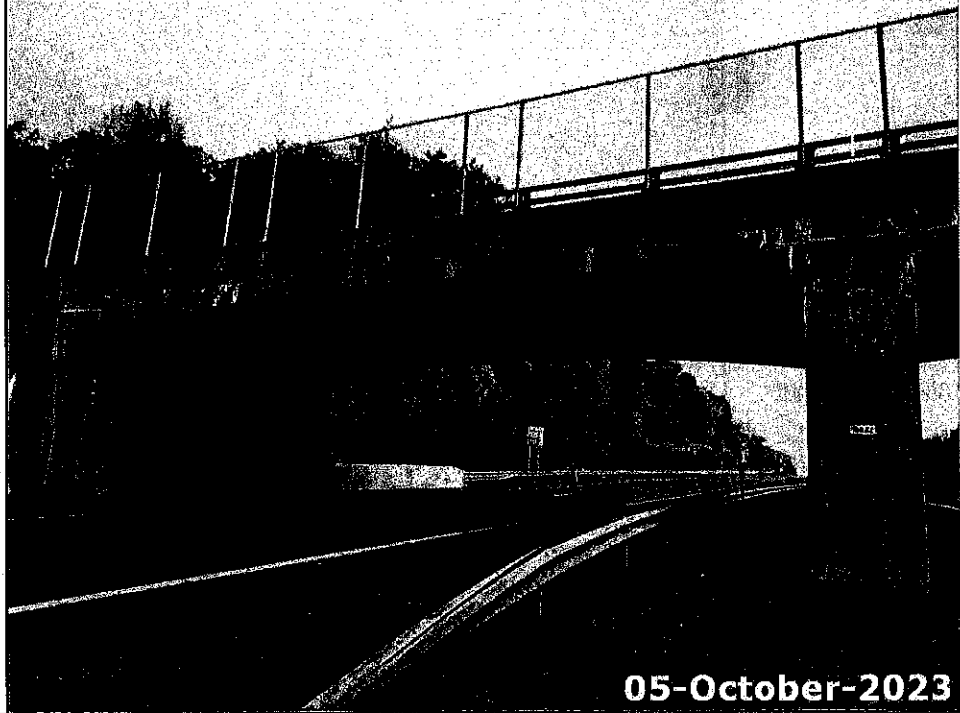
Photo Number: 13

- Cracking with efflorescence staining is seen on the right face at the begin of the span directly above pier 1.
- Two shallow pop-outs ~4"W x 8"H each, are seen on the left-fascia headwall near mid-span, due to shallow cover of underlying reinforcing steel.

Attachment Description:
Span 2 left fascia (SB)
looking right; showing
general condition and
configuration of elements,
including 2 small pop outs
and minor efflorescence.

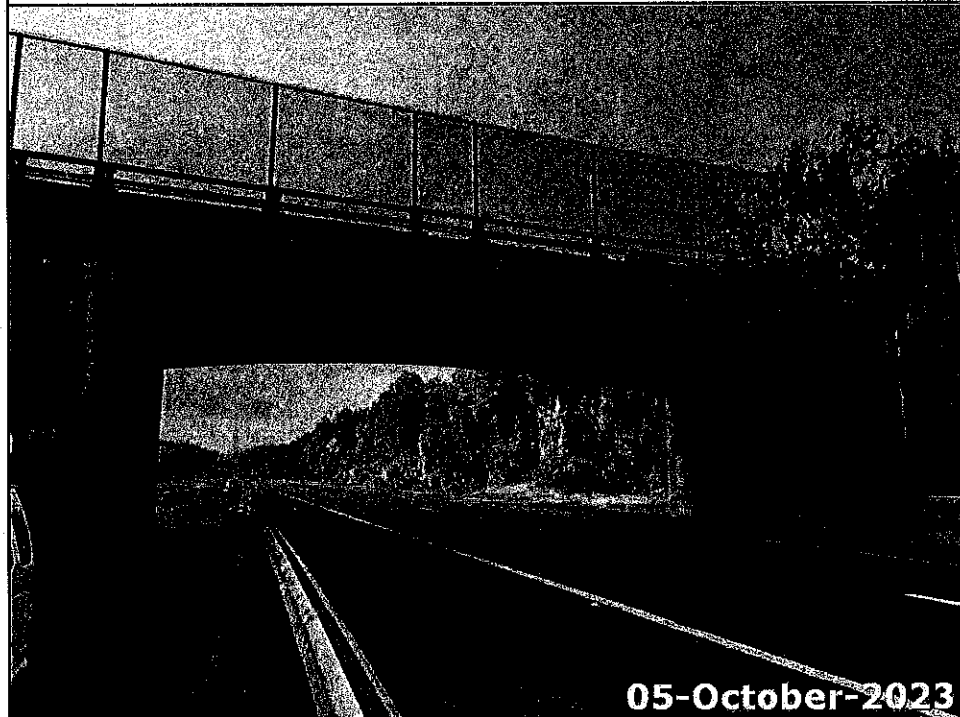
Photo Number: 14

Attachment Description:
Span 2 right fascia (SB)
looking left; showing
general condition and
configuration of elements,
including spalling/crumbling
concrete along top edge
from 1/4 span to end.

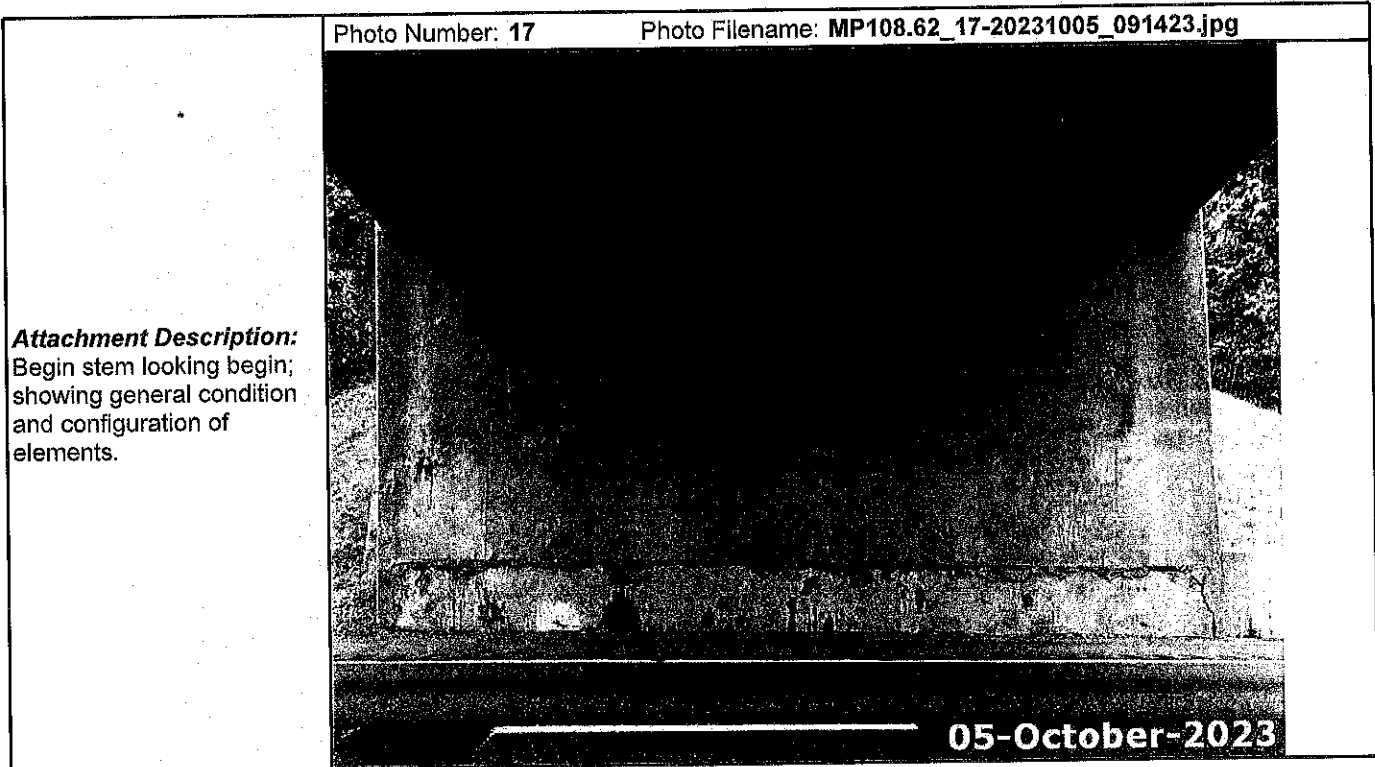
The begin stem shows a localized spall on the upper portion of the left side, measuring 1.5'W x 2'H x 2"D (photo 17).

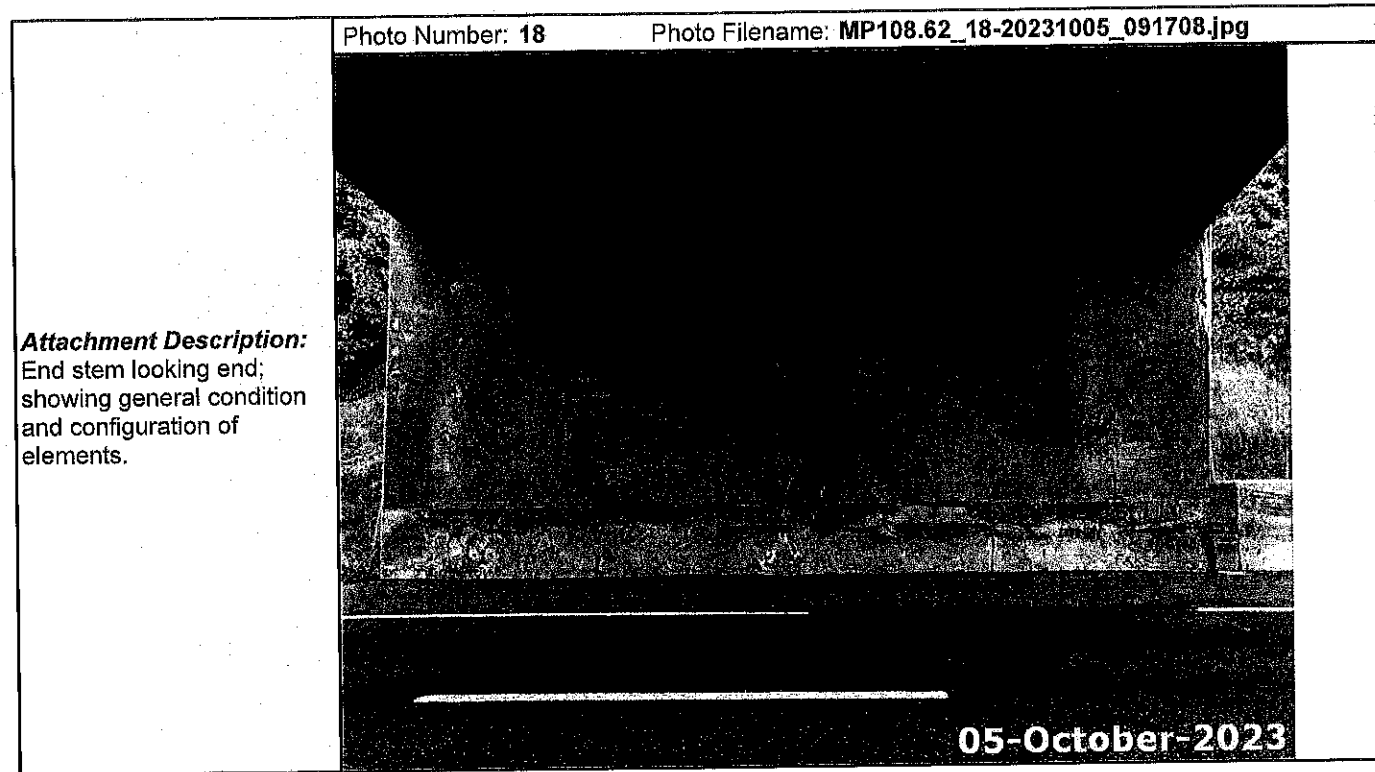
Remaining stem surfaces at each abutment show minor scaling, tight cracking, and delaminated areas (see photo 18 for the end stem).

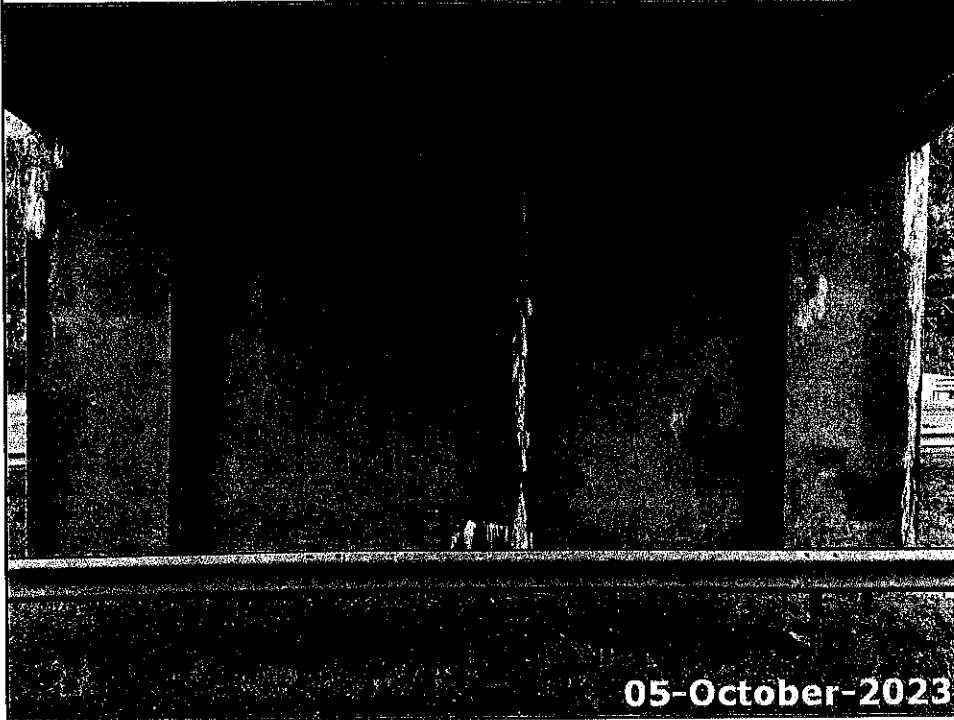
Photo Number: 19

The begin and end faces each show a full-height vertical crack, located near mid-length, with heavy efflorescence staining.

Attachment Description:
Pier 1 begin face looking
end; showing general
condition and configuration
of elements.

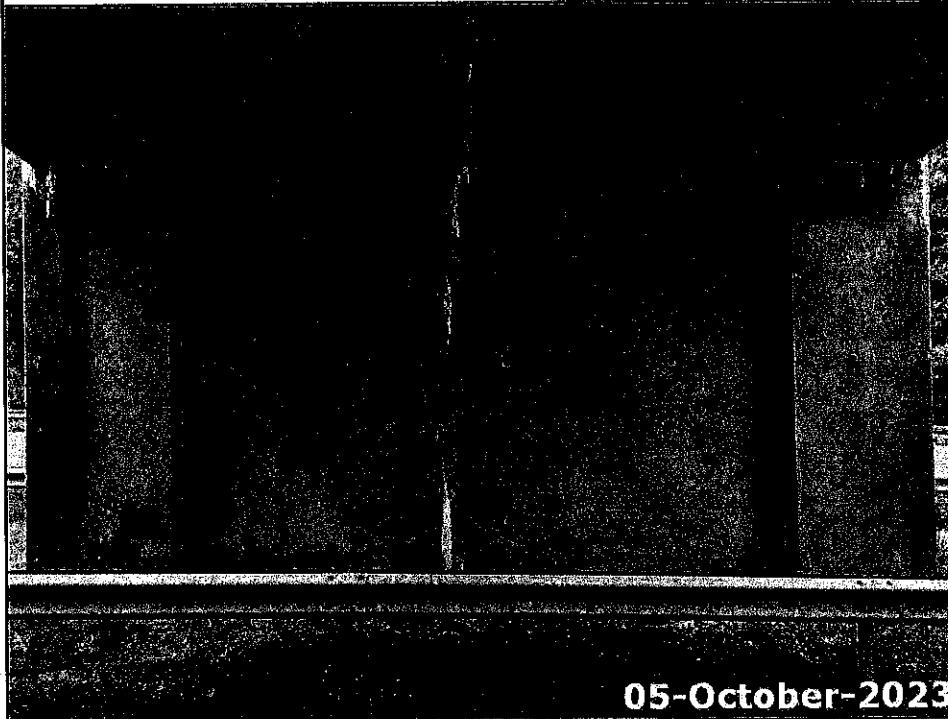
Photo Number: 20

Attachment Description:
Pier 1 end face looking
begin; showing general
condition and configuration
of elements.

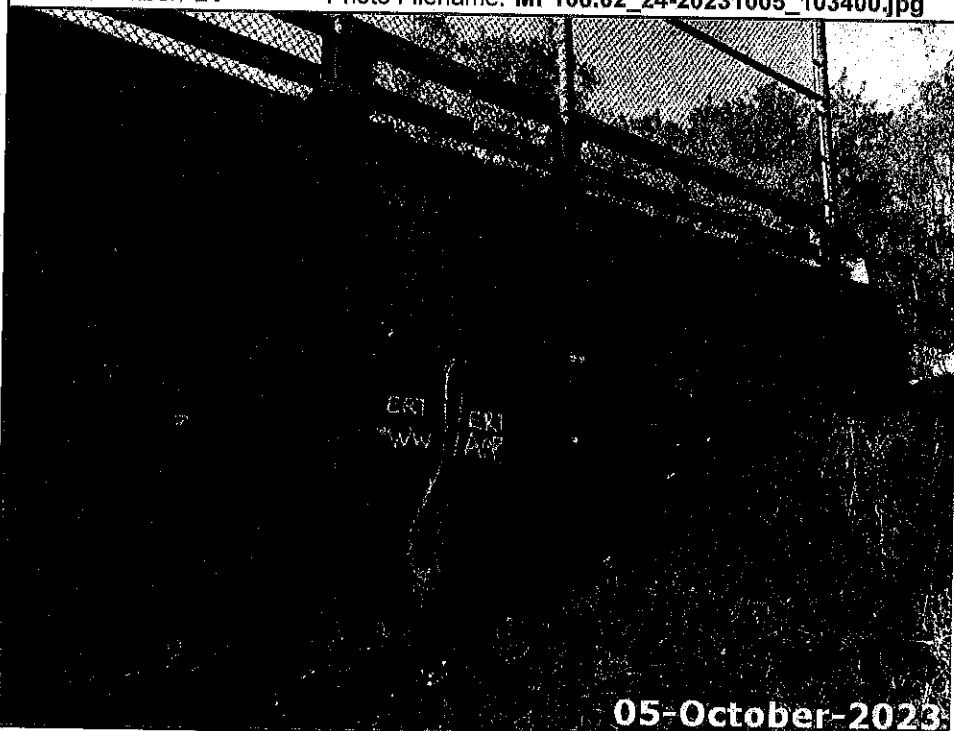
Photo Number: 24

The end wingwalls are generally in fair condition overall, with the right-side wingwall showing a localized vertical spall, located adjacent to the begin side of the vertical construction joint, measuring 6"W x 3"H x 2"D (see photo 24).

Attachment Description:
End right wingwall looking left; showing spalling concrete adjacent to construction joint.

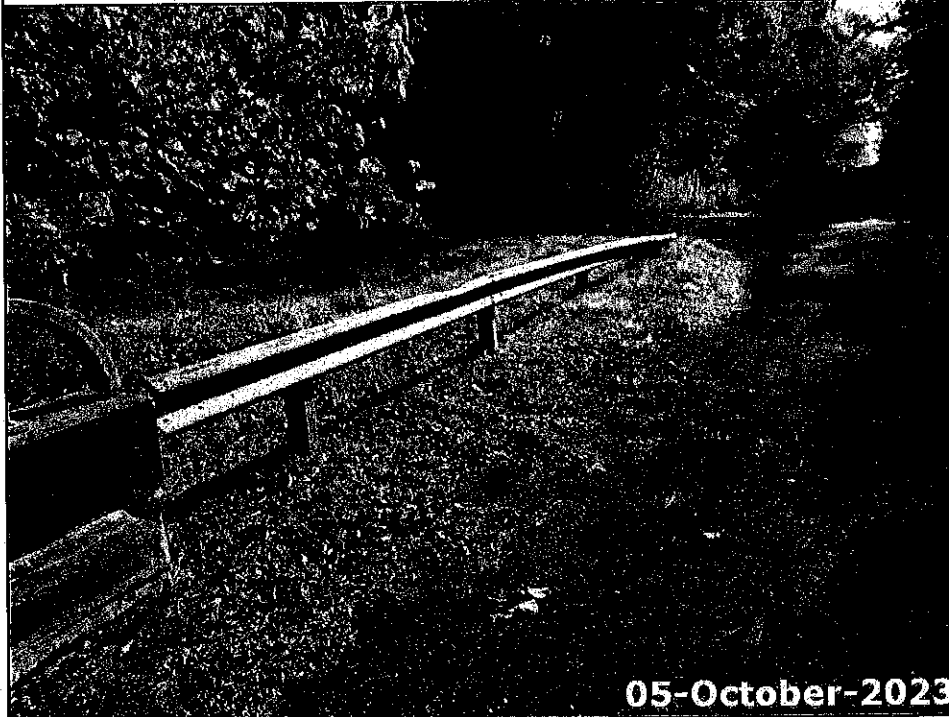
Photo Number: 26

Begin right approach railing (non-"bridge style") = 40 LF; a corrugated w-section rail with 4 posts (photo 26)
-The w-section rail at the begin right has a non-standard transition to the "bridge-style" railing.
-The posts are leaning and have inadequate spacing.
-The w-section is disconnected from the final post at the end section.

Attachment Description:
NSCO: Begin right approach rail looking begin; showing 40' of W-beam rail with leaning posts, inadequate post spacing, disconnected from post at end section, and non-standard transition to bridge.

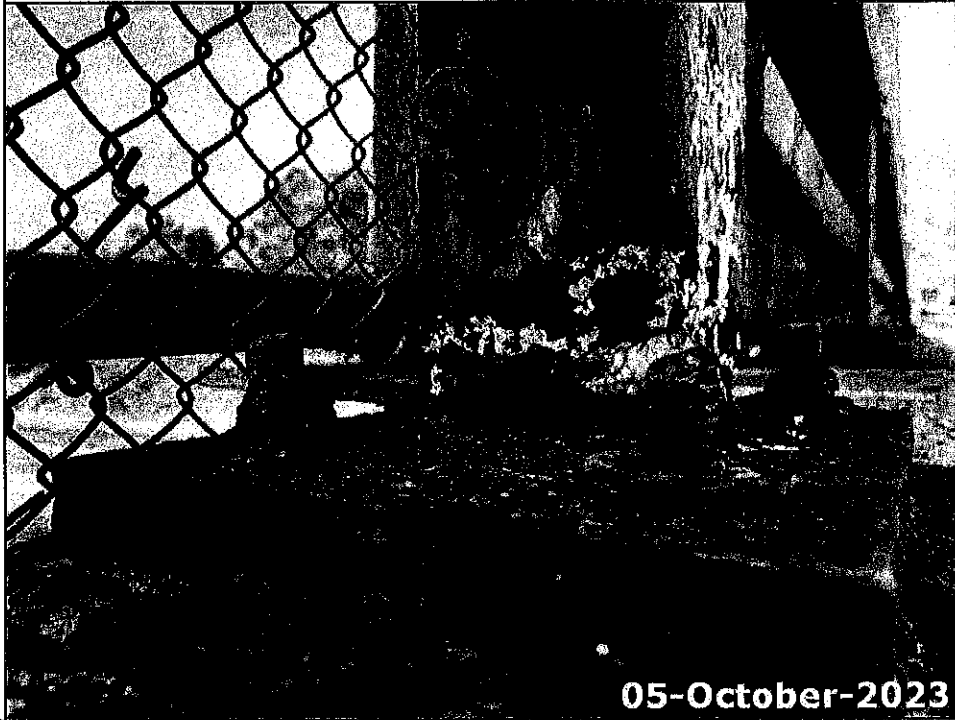
Photo Number: 27

The "bridge-style" railing located on top of each wingwall shows similar deterioration to that of the actual bridge railing, including heavy rust to the rails, posts, and anchorage hardware, perforations to the posts near the base plates, as well as 100% section loss to at least one nut at each base plate anchorage (see photo 27 for typical approach railing "bridge-style" post).

Attachment Description:
NSCO: Begin approach, left side rail at post #4 looking end; showing perforation at post base along begin, end and left sides, as well as corrosion of anchor hardware.

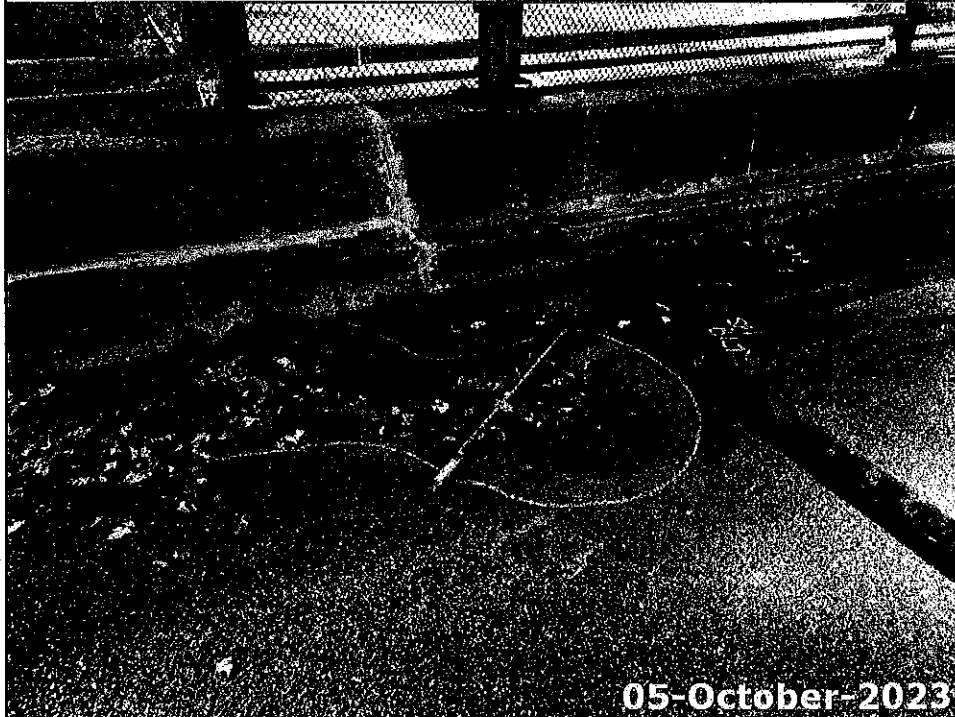
Photo Number: 28

Attachment Description:
NSCO: Begin approach, left side corner at interface looking left; showing approach settlement.

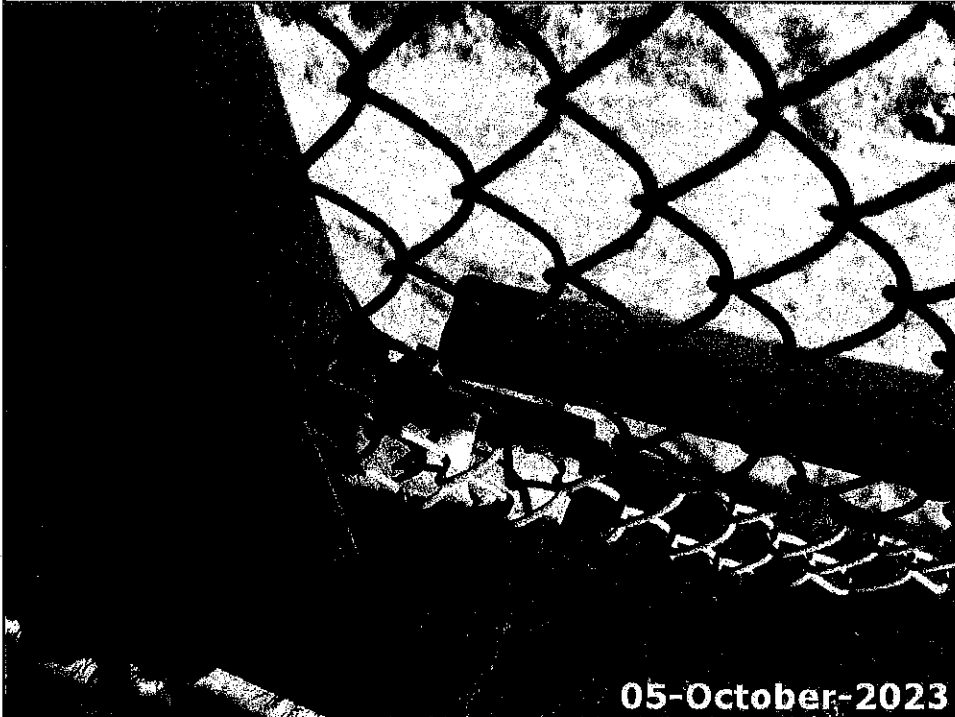
Photo Number: 30

The end right approach shows one connection of the lower pipe rail-to-post, which has corroded and severed due to rust and 100% section loss, located at the begin-side of the connection at post #3. This lower pipe railing remains secured with 5 wire ties.

Attachment Description:
NSCO: End right approach
snow fence post #3 looking
right; showing 100%
corrosion of lower pipe at
begin side of post (currently
secured w/5 wire ties).

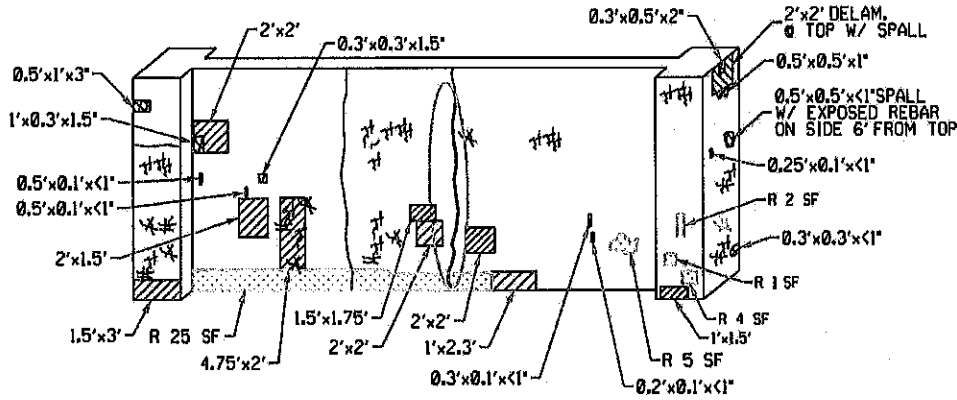
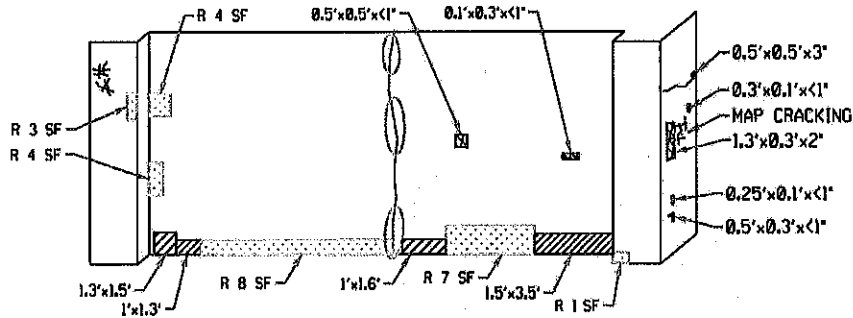
CONDITION - PIER 1

NOTE: Light to moderate scaling on both pier faces, not shown for clarity
