RE: 2023 BRIDGE INSPECTION REPORT

BIN	MILEPOST	DESCRIPTION
5513180	108.62	Brick School House Road Over the Thruway

New York State Department of Transportation General Bridge Inspection Report

Inspection Date: October 05, 2023

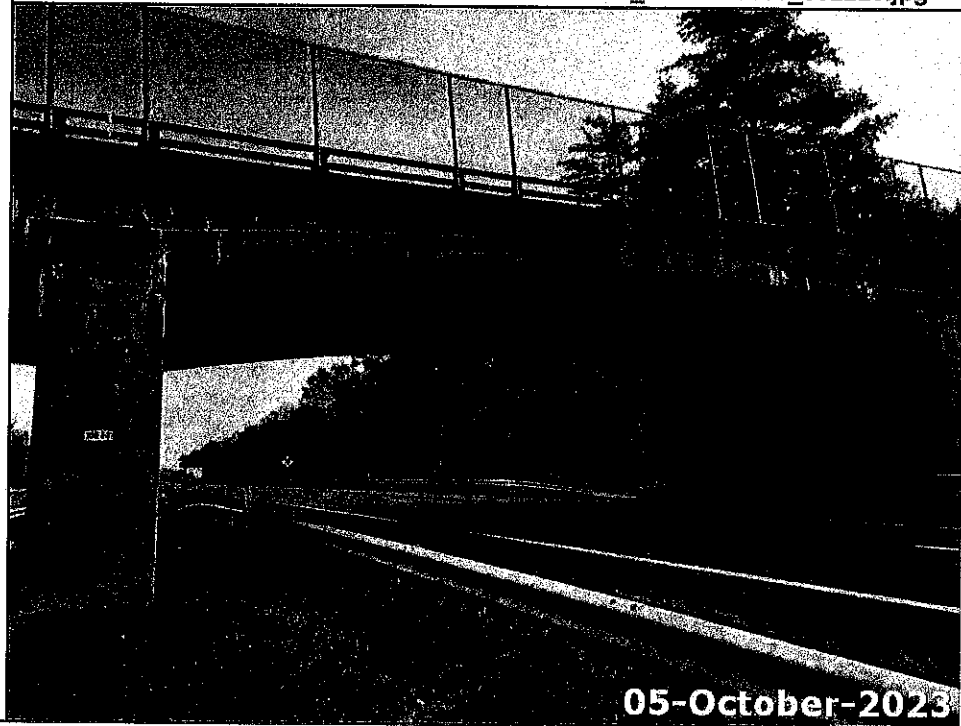
Photo Number: 12

Attachment Description:
Span 1 right fascia (NB)
looking left; showing
general condition and
configuration of elements,
including 4 small pop outs
and efflorescence.

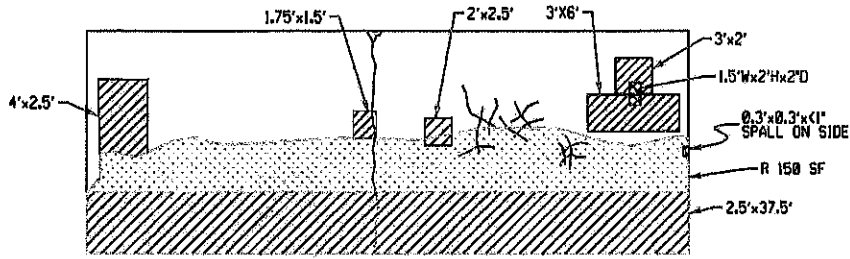
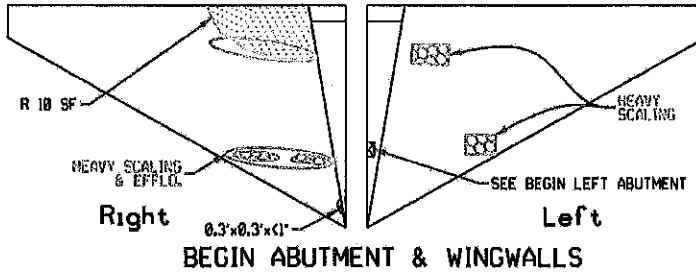
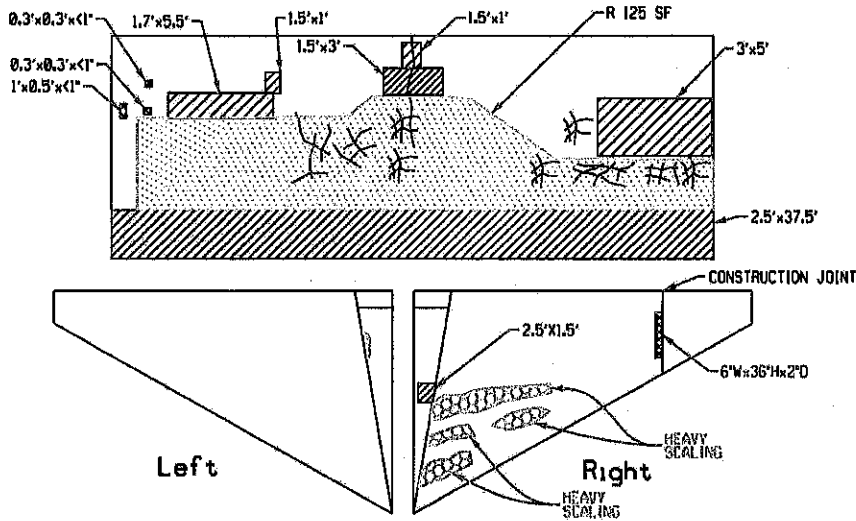
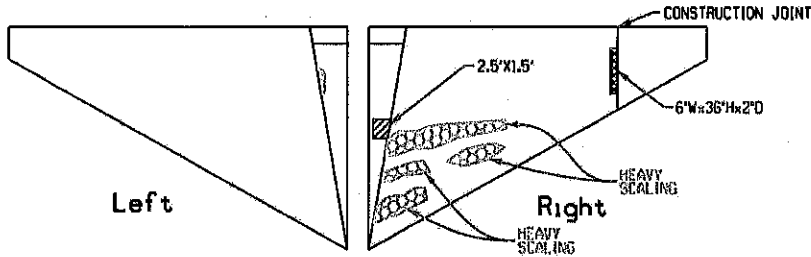
Sketch Description: MP108.62 Condition - Abutments

NOTE: 65%-70% of each wingwall's total wingwall length is affected by light to moderate concrete scaling, not shown for clarity
